**KOOTENAI DEVELOPMENT IMPOUNDMENT DAM
TOE DRAIN INVESTIGATION PROPOSAL**

February 22, 2008

BILLMAYER & HAFFERMAN ENGINEERING INC.

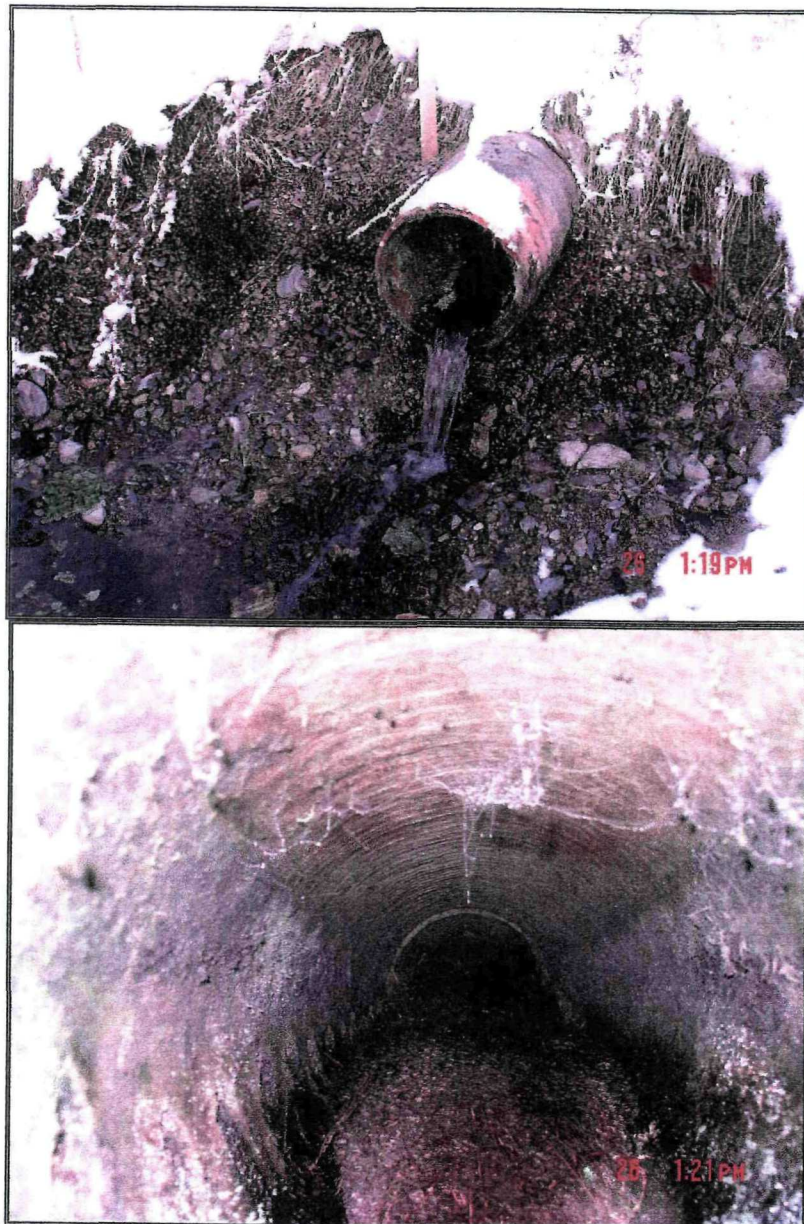
The blockage and debris in the drains was just detected but has apparently been present for a while. The cover to this report shows Drain #8 and the blockage inside the drain. Further photographs of the outside and inside of each drain is provided in the November 9th, inspection report.
